# **Diebold TSx Evaluation**

## **SECURITY ALERT: May 22, 2006** **Supplemental report, additional observations** **Unredacted on July 2, 2006 by Black Box Voting**

A Black Box Voting Project  
Prepared by: Harri Hursti

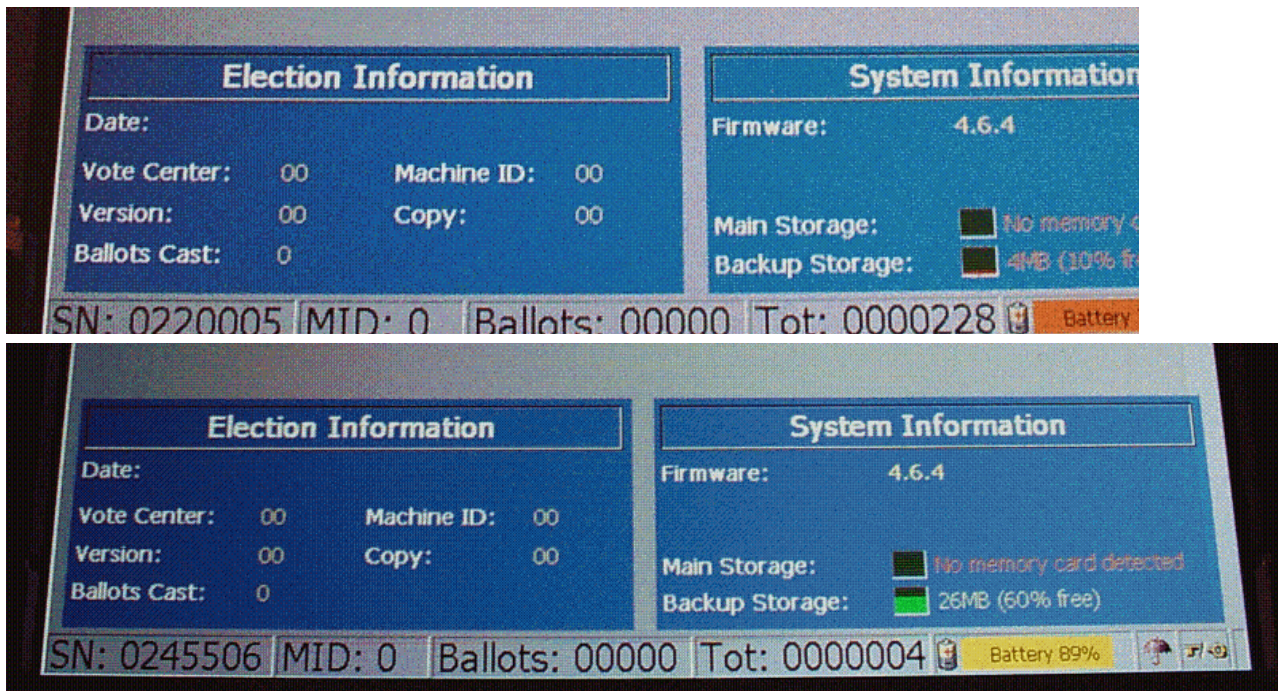
Emery County Clerk Bruce Funk noticed that some of his machines, which were marked with a yellow stick-on dot and had serial numbers in the 201000-223000 range, had screen messages indicating critically low available memory storage at the time of the delivery. Whereas machines in the 230000-255000 range had memory storage of 22-27 MB, the machines in the earlier serial number blocks had memory storage of 4-8 MB.

It was noted during this study that some machines contained test election data. Deleting this data did not free up a significant amount of memory. After this study, Diebold has explained that this lack of memory is due to the presence of extra fonts installed on some machines. No study was done to find out the reason for varying free memory sizes.

Fig. 10 – Screen shots: Variations in memory storage available

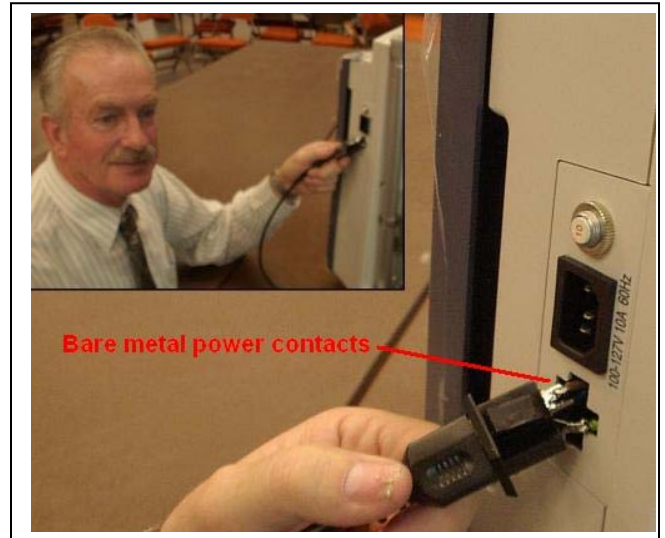
The electrical sockets on the TSx are not properly fitted to the case. Every unit examined revealed problems with sockets popping out or falling out, sometimes by simply moving the machine or through light contact with the cord. Because many polling places lack sufficient wall outlets to plug in all the machines, these machines are typically daisy-chained together

(one machine plugged to the next) with a single machine plugged in to the wall. The improperly designed socket design presents potentially an electrical hazard to poll workers and voters.

Fig. 11 – Exposed 110 volt wiring and socket falling out

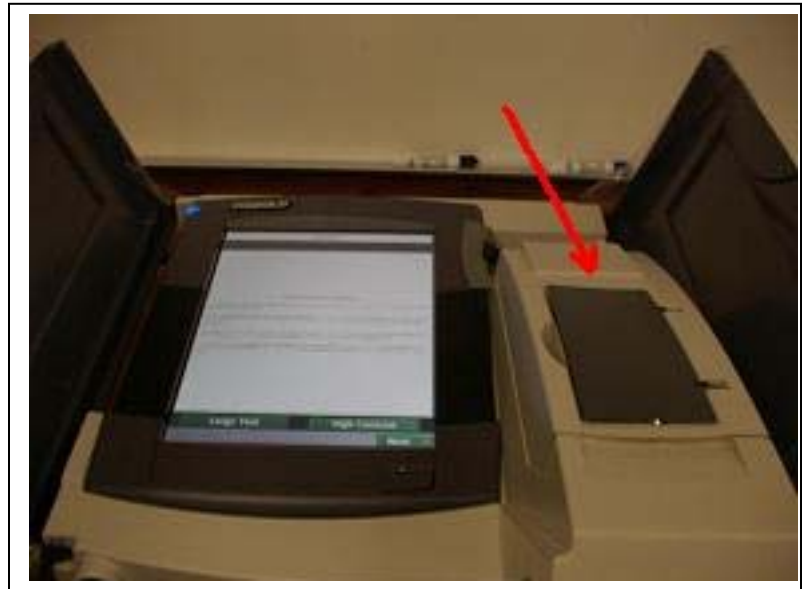
In addition, a design decision to place a brown door over the paper which the voter is supposed to verify leads to questions about the usefulness of the VVPAT. Unless the door is

Fig. 13 – Brown door blocking view of voter verifiable paper trail

lifted up it obstructs view of the paper representation of the voter's vote. If the system is to be used to verify a paper trail, it should have instructions printed prominently on the casing instructing voters to lift the brown door to see the paper trail.

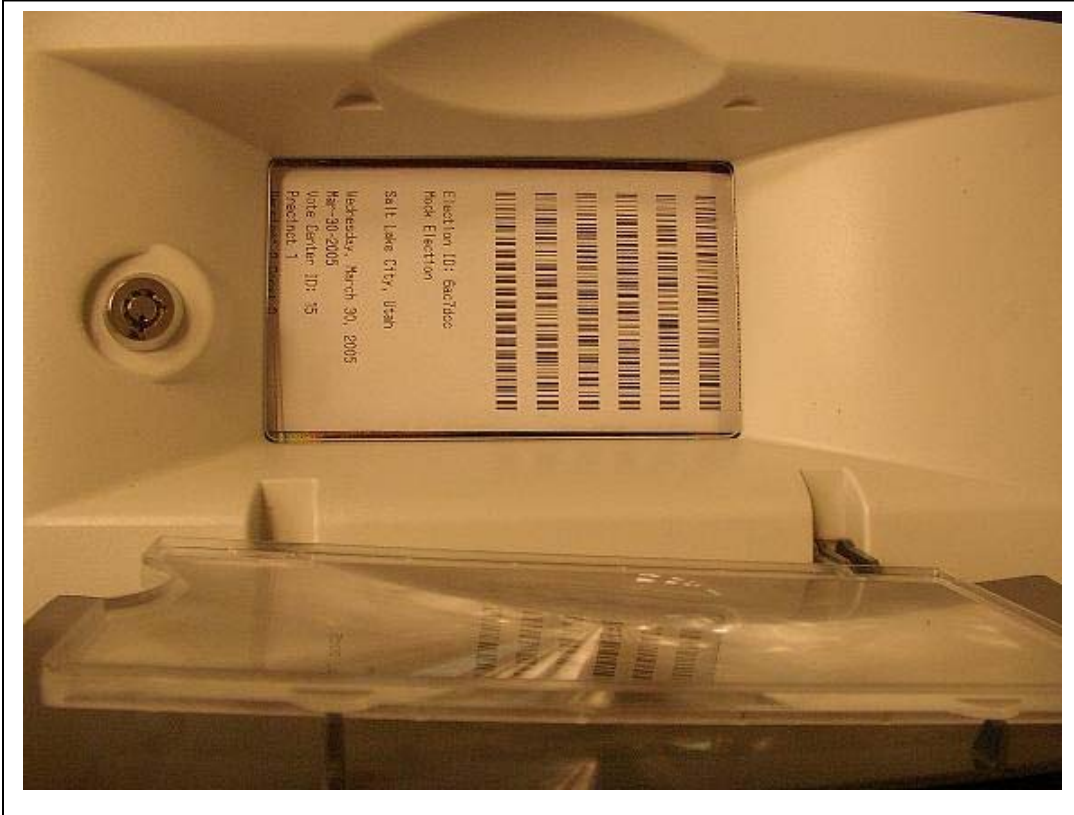
The voter can lift the lens, but the print is very small and the bottom of the paper record of the vote does not display fully.

Fig. 15 – Print is small; lower part of paper trail tends not to scroll up into full view.
