Three Major Problems with the LibertyVote DRE Voter Verified Paper Audit Trail

New York State requires that DRE style voting machines “produce and retain a voter verified permanent paper record which shall be presented to the voter.” The LibertyVote DRE currently under consideration in New York State uses a Voter Verified Paper Audit Trail (VVPAT) which has three major usability flaws which make it effectively unusable by voters, and therefore unable to meet the requirements of New York State law.

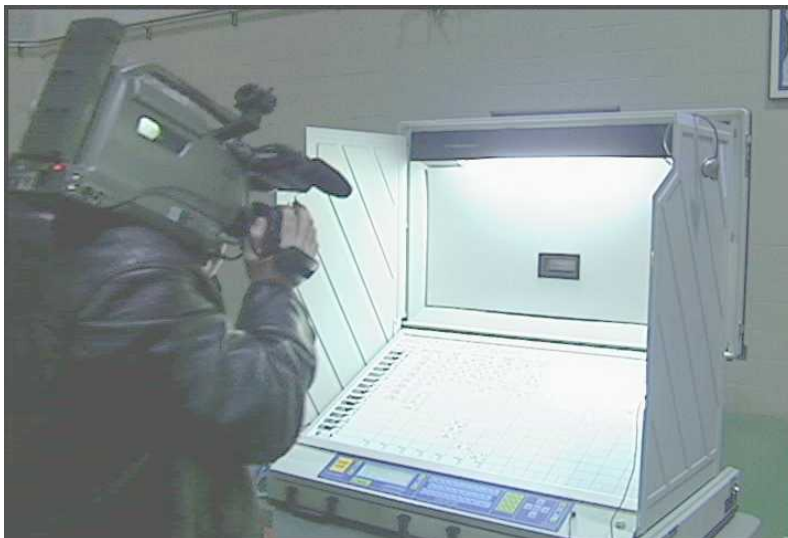
In addition, the extremely small size of the VVPAT window, and its distance from the voter, makes it extremely difficult to read.

This increases the probability that the paper audit trail will not be reviewed by the voter.

Photo showing size of the VVPAT window relative to a person.

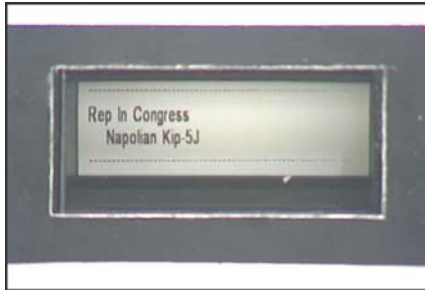
Display After Voter Makes a Selection

The VVPAT window, located on the rear surface of the DRE, displays only a single ballot choice as each selection or de-selection is made by the voter.

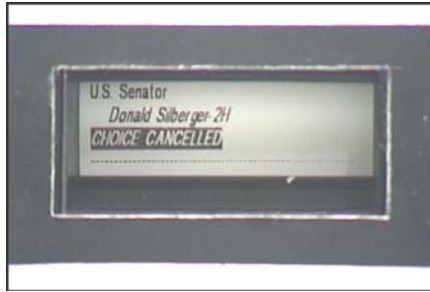
Display After Voter Cancels a Selection

If the voter changes his mind and deselects that choice, the name is displayed in italics with the words CHOICE CANCELLED printed below the name.

But since the voter can never see the entire VVPAT, there is no way to compare the single line item to other items that occurred earlier.

Display of only a single choice at a time is a serious usability issue. The lack of full context is confusing and the order that the voter's choices were selected and deselected is not clear.

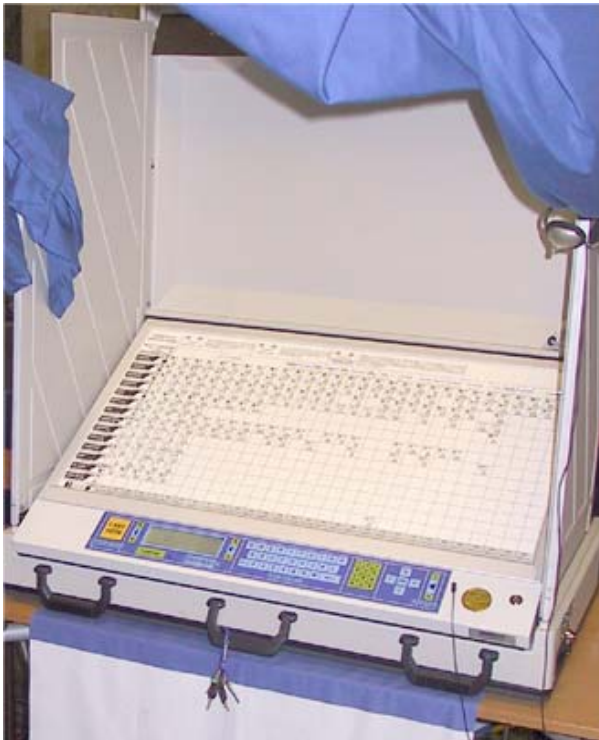
In this picture we see a LibertyVote DRE with over 200 ballot positions. Each square, or ballot position, has a small symbol printed in it. The positions in the first column are labeled, moving down: 1A, 1B, 1C, etc. The second column positions are labeled 2A, 2B, 2C, and so on.

In order to review the accuracy of the VVPAT “Final Summary”, the voter must find the ballot position which corresponds to each symbol on the printout, noting which candidate is listed there.

Asking a voter to read a tiny printed symbol and then match it to another symbol among 200+ ballot positions is a nearly impossible task, and will lead to the vast majority of voters never reviewing the VVPAT – *it’s just too hard to do.*
